# Intraluminal pressure in central venous hemodialysis catheters during power injection of contrast media

**Short title:** Hemodialysis catheter contrast media injection

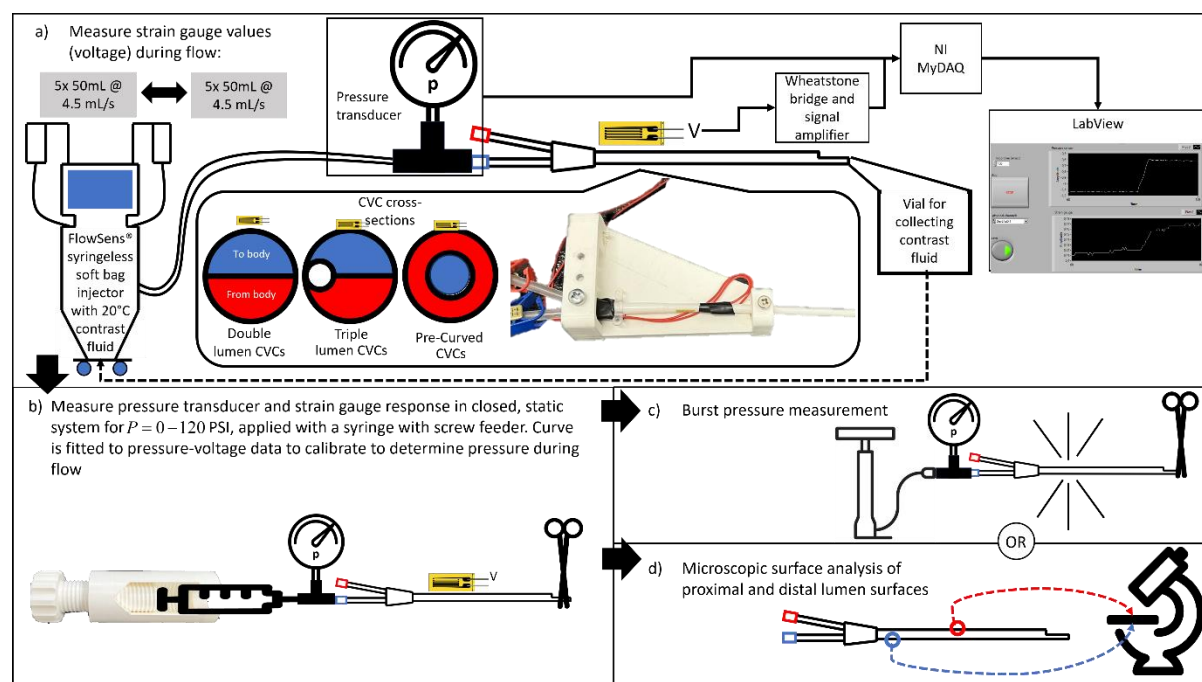
Figure 1: The experimental setup for testing the central venous catheters: a) the catheters with strain gauges are clamped and connected to a contrast medium injector with a pressure transducer placed at the inlet of the catheter. b) The strain gauges are then calibrated through static pressure. The pressure transducer values are stored together with the strain gauge voltages. Next the pressure transducer and strain gauge voltages are processed, and a curve fit is generated. Intraluminal pressure during injection is determined through this curve fit. c) catheters are finally pressurized until burst; or d) microscopic surface analysis is performed on the lumina of 1 sample of each catheter types tested.

The CVCs are tested by repeated injection of CM and recording the response with the strain gauge. The strain gauges are then calibrated with a pressure transducer in a closed system with static pressure in which pressure is equal everywhere and in all directions. Calibration is performed after the CM injection; the pressure necessary to properly calibrate the sensors must exceed the pressure induced by the CM, and therefore may damage the CVCs and distort the pressure recordings if performed prior to the power injections. Finally, the CVCs are either burst or dissected for microscopic surface analysis. The experimental setup is displayed in Figure 1.

Austin, TX, USA). Each tested CVC sample was fixated at two points (Figure 1a) to ensure no deformation of the catheter occurs, other than induced by pressure.

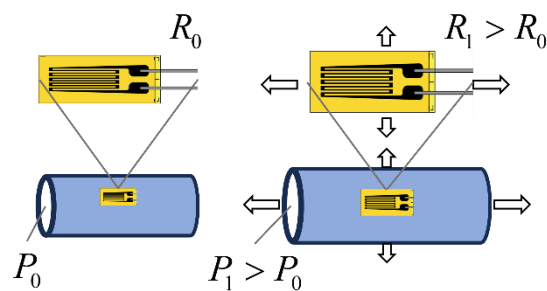
Figure 2: Working principle of a strain gauge. The strain gauge is placed on a surface and the resistance  $R$  is continuously measured, of which the value is  $R_0$  at rest with intraluminal pressure  $P_0$ . When the material stretches, e.g. due to a higher intraluminal pressure  $P_1$ , the strain deforms with the material. The resistance of the deformed gauge  $R_1$  will increase due to the increase in length and decrease in cross-sectional diameter of the wire. This can then be measured as a voltage change when amplified in a Wheatstone bridge.

The working principle of a strain gauge is shown in Figure 2. Deformation of the material on to which the gauges are placed results in deformation of the thin wires. This in turn results in a change in resistance which can be accurately measured. Materials deform predictably when stress is applied. Intraluminal pressure introduces such stresses in the wall of the CVCs, so strain gauges may be utilized to measure this deformation. The strain can thus be related to an intraluminal pressure when calibrated with a pressure transducer in a static closed system. Additionally, such strain gauges are typically used to determine material wear and fatigue over time. As such, they may provide information relating to such effects occurring in the CVC material with CM injection.

The pre-curved CVC do not have the same “double-D” cross section, but an inner (distal) and outer (proximal) lumen (Figure 2a). A strain gauge could not be directly applied to the wall of the distal lumen. The gauges were fixed on the wall of the proximal lumen and measurements were conducted through this lumen. However, for 3 of the 4 samples, injection with the power injector was repeated with both lumina and maximum injection pressure was recorded for both to assess for similarity. The inner lumen in the remaining sample was spared for microscopic surface analysis.

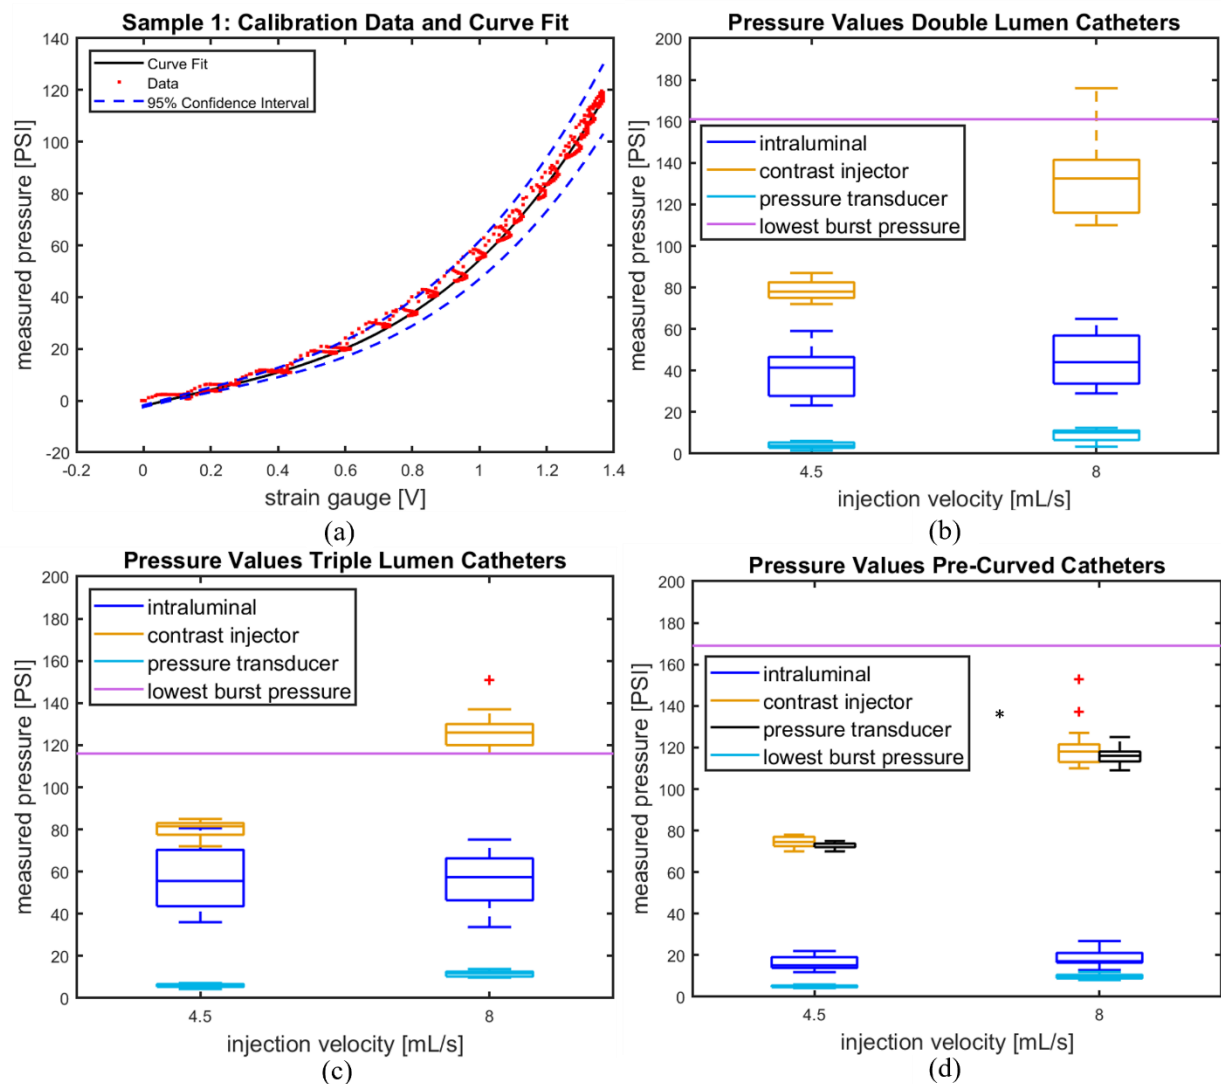
Figure 3: a) The calibration data, fitted 3<sup>rd</sup>-order polynomial and its 95% confidence bounds of catheter sample 1, used to determine intraluminal pressure with the strain gauge. b-d) Boxplots of the pump pressures, intraluminal strain gauge pressures and pressure transducer values at injection velocities 4.5 mL/s and 8 mL/s, and the burst pressures of b) the double lumen catheters; c) the triple lumen catheters; and d) the pre-curved catheters. n=4 applies to (b-d) \*Only 3 samples have been tested

All CVCs were successfully tested and calibrated. A 3<sup>rd</sup>-order polynomial curve was fitted to the calibration data of each CVC, and these curves were used to determine the intraluminal pressure during CM injection. As an example, Figure 3a shows the calibration data, curve fit and 95% confidence bounds of this fit in of a double lumen CVC tested. The complete set of calibration figures can be found in Supplemental Figures S1-S3.

Figures 3b-d display the pump pressures, intraluminal strain gauge pressures (determined with the fitted calibration curves), pressure transducer values at injection velocities 4.5 mL/s and 8 mL/s, and the lowest recorded burst pressures of the 3 different CVC types.

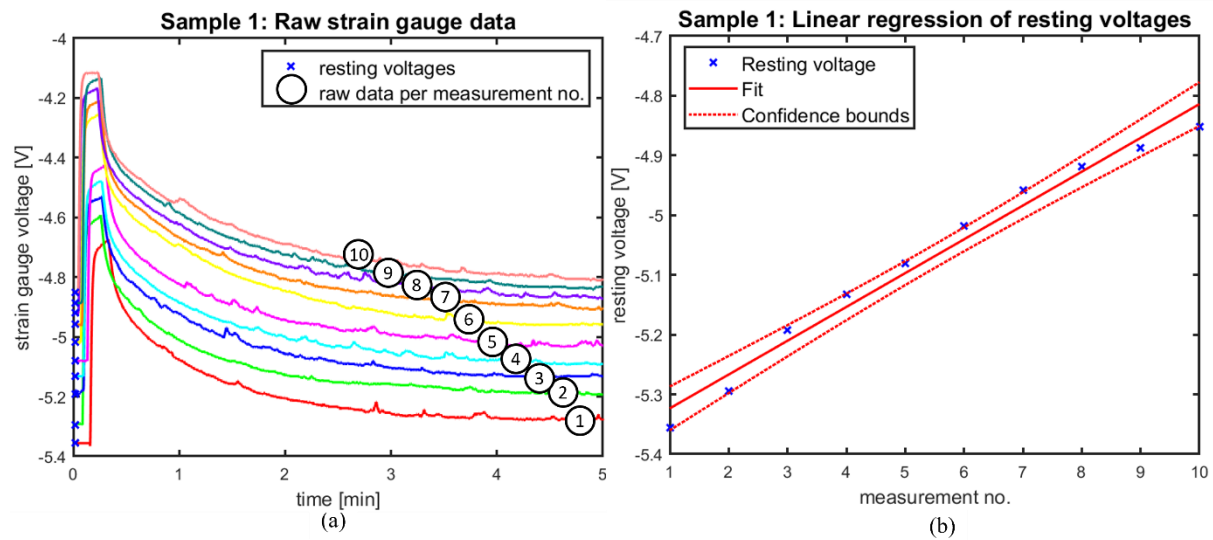
Figure 4: Representative regression plot of catheter 1 showing the trend in resting voltages throughout the measurements. Patterns are similar throughout the tested catheters. a) shows the raw strain gauge data over the 5-minute testing period of measurements 1 through 10 in catheter 1, as indicated by the numbers in the graph; and b) displays the regression analysis of the resting voltages as indicated in a).

Material fatigue, or permanent strain of the CVC, is assessed for each sample tested. Linear regression is applied to the strain gauge voltage at rest, which corresponds to the material strain at rest and fatigue. The linear regression coefficients are non-zero ( $p < 0.05$ ) in every CVC tested, except CVC sample 2 (double lumen,  $p = 0.53$ ). As an example, Figure 4 displays the raw strain gauge data of the first CVC measured together with the linear regression analysis performed on the resting voltages of this CVC. Figure 5 displays the linear regression

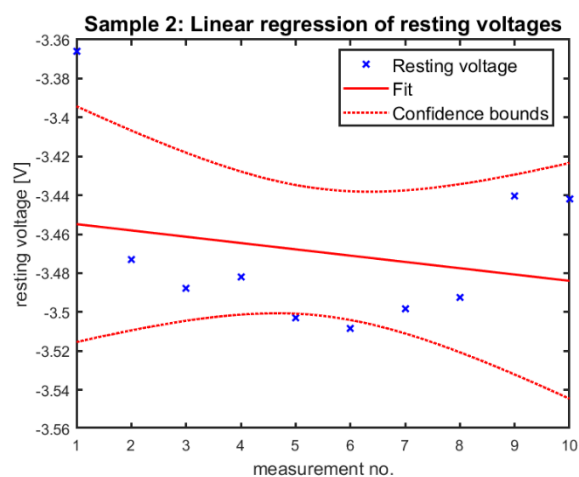
Figure 5: Fatigue analysis of catheter sample 2. This is the only catheter in which the linear regression coefficient was not statistically significantly non-zero.

analysis of CVC sample 2, the only sample in which the linear regression coefficient was not significantly non-zero. The complete set of linear regression analyses is found in Supplemental Figures S4-S6.

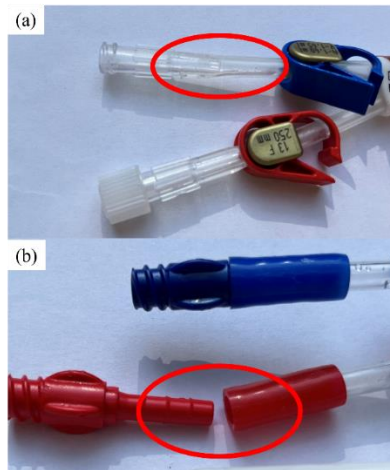
468 *Figure 6: Failure modes of the central venous catheters at burst pressures: a) failure of the inlet tube resulting in rupture;*

469 *and b) dislocation of the inlet tube connector.*

All CVCs failed at one of the locations displayed in Figure 6 during burst pressure measurement. Burst pressures and the failure location at burst pressure are also recorded in Table 1.

These data suggest that intraluminal pressure values during CM injection are sufficiently low as to not cause rupture of the CVCs included in our study. Failure of the CVCs at bursting pressure always occurred at the inlet, which in clinical use will remain outside the body. However, the stretching of the material and increase in micro-crack size and density suggested damage accumulates with repeated CM injection. The micro-cracks may increase risks of thrombus formation in the CVC but remains to be studied. With the velocities tested, incidental use likely carries little risk, especially with relatively new CVCs that have not yet been frequently subjected to intraluminal pressure. However, these medical devices remain uncertified for this use case. Therefore, caution must be taken and caretakers must understand that liability is shifted away from the manufacturer when using such CVCs for CM injection. Clinical use of CVCs for this purpose has previously been shown to be safe and effective, provided adequate protocols are in place.<sup>16</sup> For example, a sufficiently safe maximum pressure should be placed on the injector. If a blockage would be present in the CVC preventing flow, the injector pressure would equate to the intraluminal pressure in the CVC, which could cause damage or even rupture.

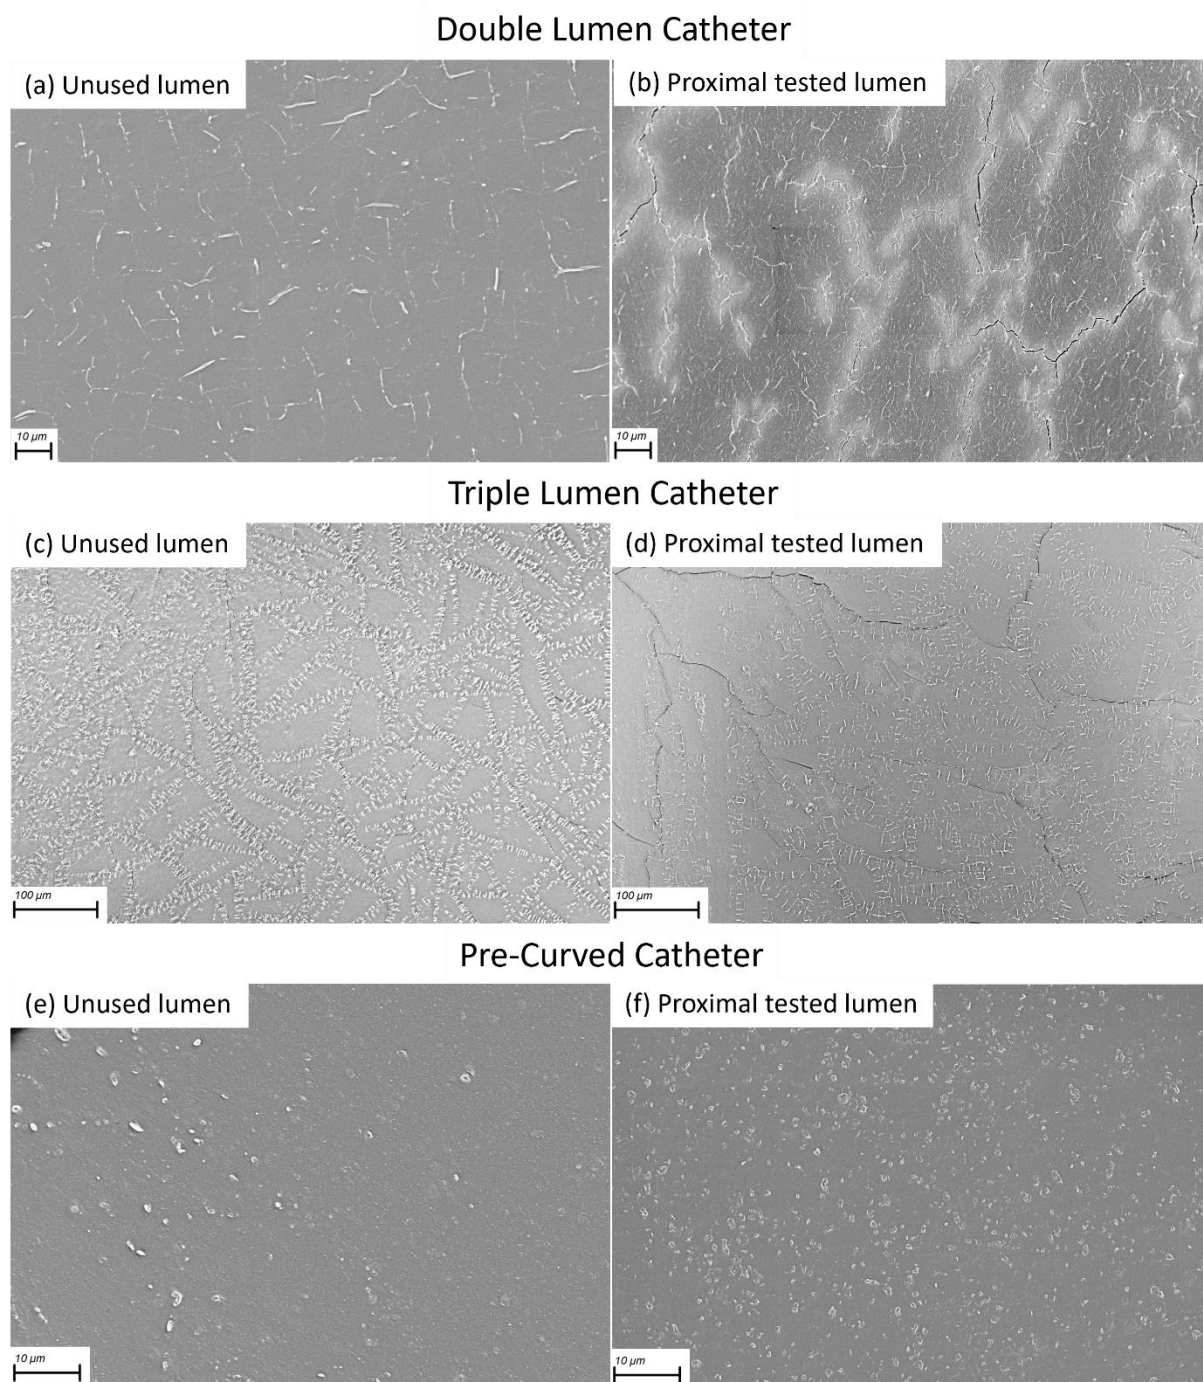
Figure 7: Surface analysis through scanning electron microscopy of: a) unused lumen, and b) proximal part of the tested lumen, of the double lumen catheter; c) unused lumen, and d) proximal part of the tested lumen of the triple lumen catheter; e) unused lumen, and f) proximal part of the tested lumen, of the pre-curved catheter. Small white dots and lines visible in all images are identified as pores in the material. The black lines are indicative of micro-cracks. There are notable differences in the luminal surfaces across the various types of catheters. The magnifications used were selected to best illustrate the surface changes in each catheter type before and after exposure to contrast medium injection.

The microscopic surface analysis of the 3 CVCs examined is depicted in Figure 7. Figures 7a shows the unused lumen, and Figure 7b the proximal part of the tested lumen of the double lumen catheter. Magnification has been chosen to best illustrate the differences in the surface in each CVC. The unused and tested lumen of the triple lumen CVC are shown in Figures 7c and 7d, respectively. Finally, Figures 7e and 7f display the unused and tested lumina, respectively, of the pre-curved CVC. With the unused lumina as control, the pictures of the tested lumina show an increase in size and density of micro-cracks in the double and triple lumen CVCs. These micro-cracks present themselves as clear black lines in the microscopy images. However, this contrast is less apparent in the pre-curved CVC.

The fatigue measured in the CVCs over the power injections recorded by the strain gauges is further supported by the microscopic surface analysis. The microscopy shows an increase in size and density of micro-cracks between the unused and tested luminal surfaces in the double and triple lumen CVCs. These cracks seem to propagate along what appear to be small pores in the material. Propagation is likely induced by the pressure of the CM injection. Electron microscopy in literature of similar dialysis CVCs exposed to normal use and explanted from patients do not show such clear micro-cracks.<sup>24,25</sup> This upholds the notion that the high pressure and viscosity of the CM can cause permanent damage to the CVC surfaces. In the

pre-curved CVCs, no such phenomenon is clearly visible. This could be due to the intraluminal pressures in the pre-curved CVCs being lower, but the material itself also appears smoother.
